# Home Condition Survey

8, Rowan Way  
NORTHAMPTON  
NN5 0DT

Report Reference No: 5359009  
Date: 26-May-2015  
Surveyor: Mrs Carolyn Clay

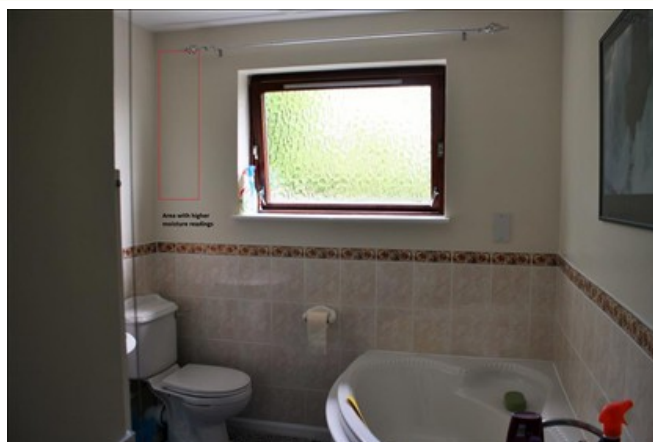
Tests revealed that there is a small area with higher readings to the rear elevation of the Main Bathroom. See Section E3.

Main bathroom showing area with damp

| <b>E3.</b><br><b>Inside</b><br><b>walls,</b><br><b>partitions</b><br><b>&amp;</b><br><b>plasterwork</b><br><br><b>Main</b><br><b>bathroom</b><br><b>external</b><br><b>wall</b> | <p>The external wall has been finished with a skim coat of plaster. There are ceramic tiles covering the base half of the wall.</p> <p>Higher moisture readings were discovered to this wall in the LH corner above the tiles. The soil and vent pipe is concealed in the wall in this area and could be the cause. See Dampness in Section B and Section D4 for further information.</p> <p>This area should be observed and if possible the cause of the high readings should be determined.</p> | <p>2</p> |

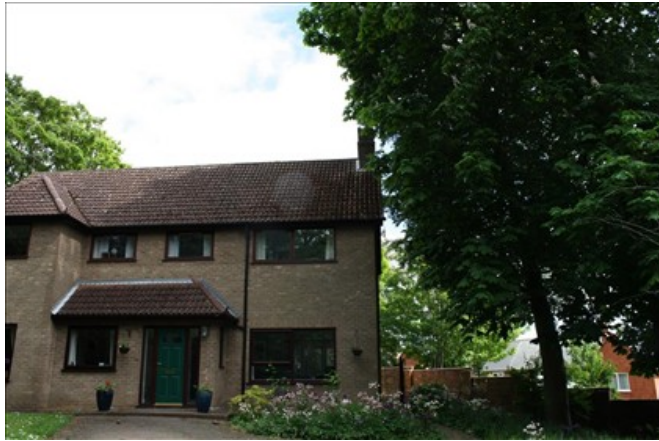
I understand that at least one tree within the boundary of the property has a Tree Preservation Order.

Tree to RHS of house

Trees to RHS of house

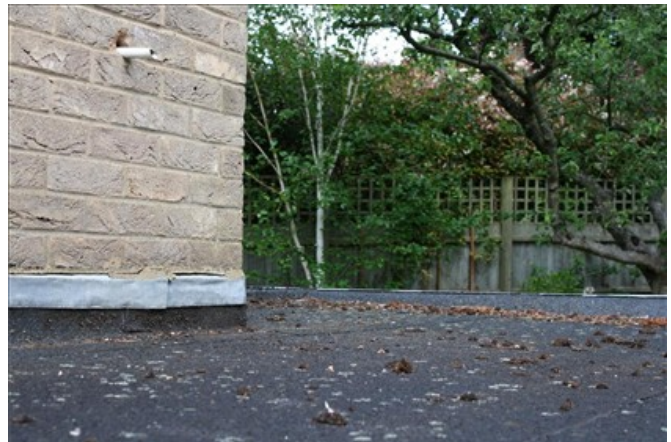
| | Description and Justification for Rating and any comments | Condition Rating |
|---|---|---|
| <b>D2.</b><br><b>Roof coverings</b><br><br><b>Flat Roof</b> | <p>The Utility Room roof is flat and covered with roofing felt.</p> <p>The felt is in good condition.</p> <p>No repair is presently required. Normal maintenance must be undertaken.</p> | 1 |

Flat Roof

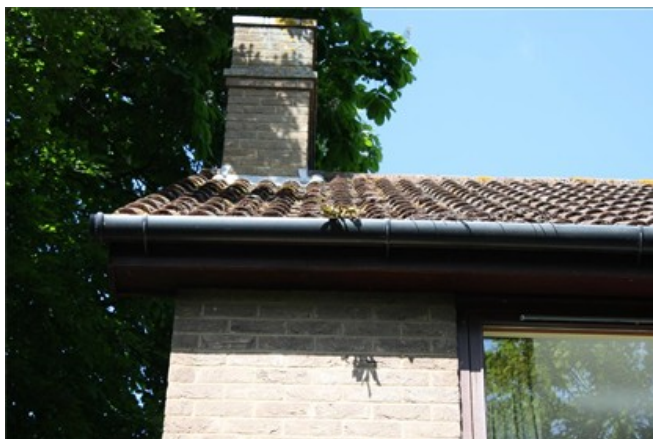
| <b>D3.<br/>Rainwater<br/>pipes &amp;<br/>gutters</b> | <p>Gutters and downpipes are the original, formed in PVC and are supported by plastic brackets fixed to the fascia board.</p> <p>Gutters are in generally acceptable condition.</p> <p>It is essential that the gutters are kept free of debris, such as leaves, as this can prevent proper draining resulting in rot and decay to other parts of the building. Due to the number of trees in this garden the gutters should be cleared on a regular basis as part of a maintenance program.</p> | <p>1</p> |

Rear Roof, leaves on roof and in gutter

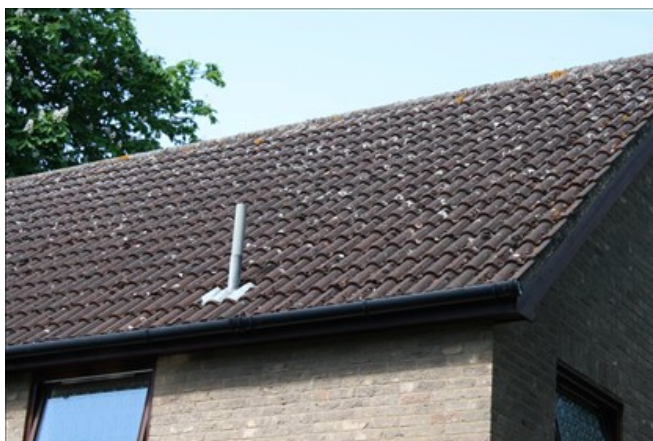
| <b>D4.<br/>Above<br/>ground<br/>waste &amp;<br/>soil pipes</b> | <p>The above ground waste water pipes are plastic.</p> <p>The bathroom soil and vent pipe terminates above the rear roof.</p> <p>There is no cover or wire cage on the top of the soil and vent pipe. This should be fitted to stop leaves and other debris blocking the pipe.</p> | <p>2</p> |

uncapped soil and vent pipe

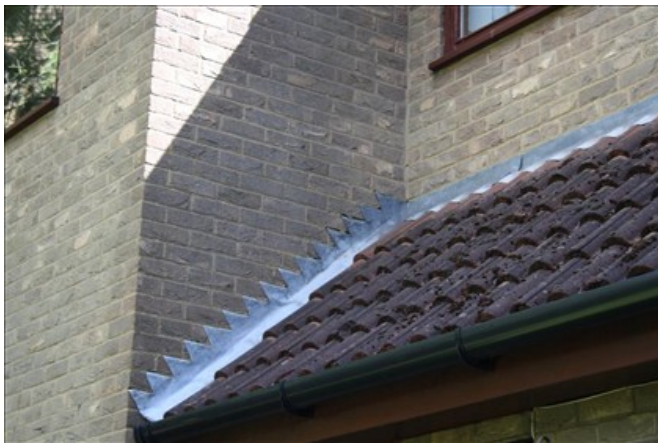
porch roof meets wall - some missing mortar

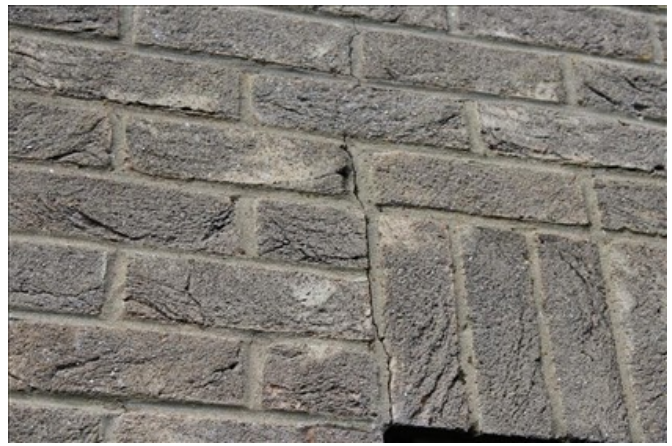
Crack to wall above patio doors

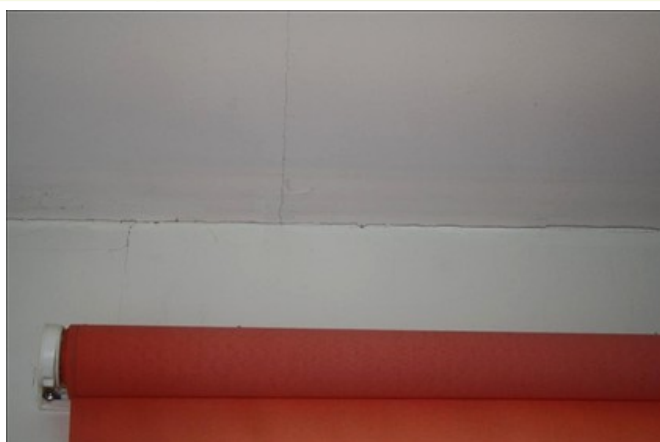
minor cracking where ceiling meets wall

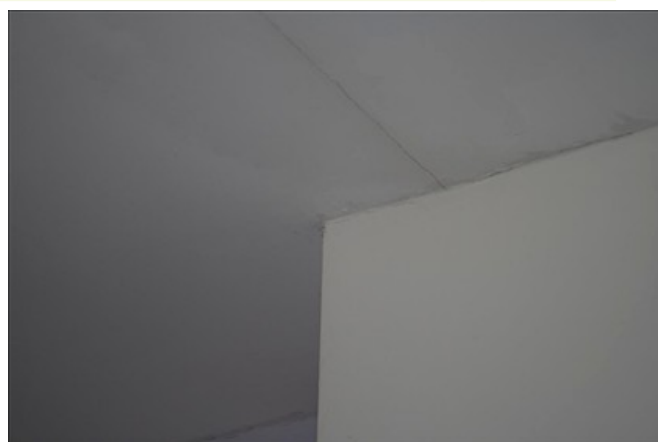
cracking along ceiling plasterboard joints

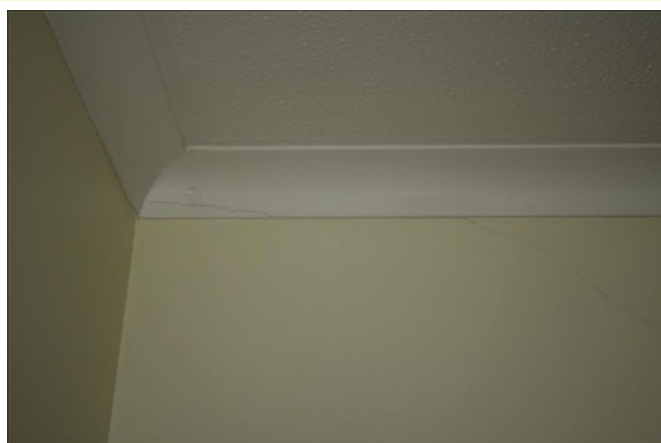
minor cracking

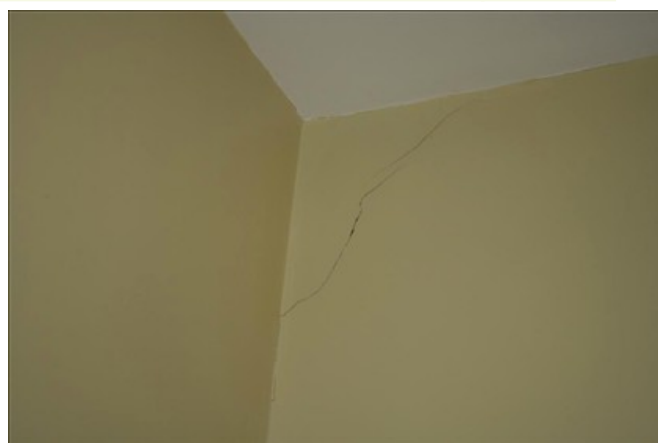
cracking in Dining Room

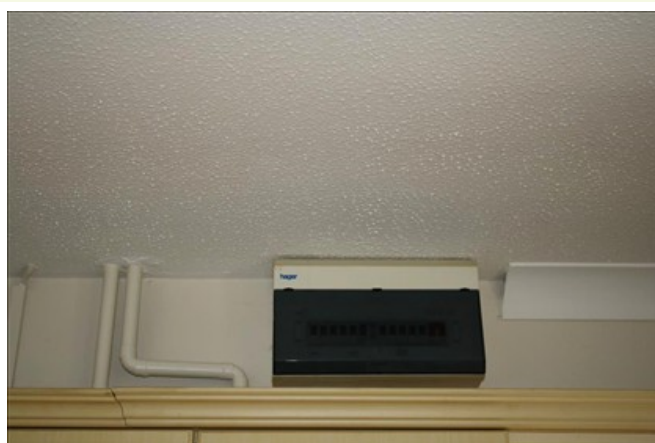
| <b>F1.<br/>Electricity</b> | <p>The property is connected to the main electricity supply and the meter is located in an external box.</p> <p>The consumer unit [fuse box] is a modern RCD unit which has been fitted in the last 10 years. The power sockets are provided on a modern ring main and lighting is provided to every room.</p> <p>The provision of power outlets could be considered insufficient for modern requirements which increases the temptation to use extension leads. These can present a variety of hazards and should be avoided.</p> <p>No recent test certificate is available. The absence of such a test certificate is a hazard [see Section C] and necessitates the imposition of a Condition 3 Rating.</p> | <b>3</b> |

Consumer unit, above kitchen cupboard

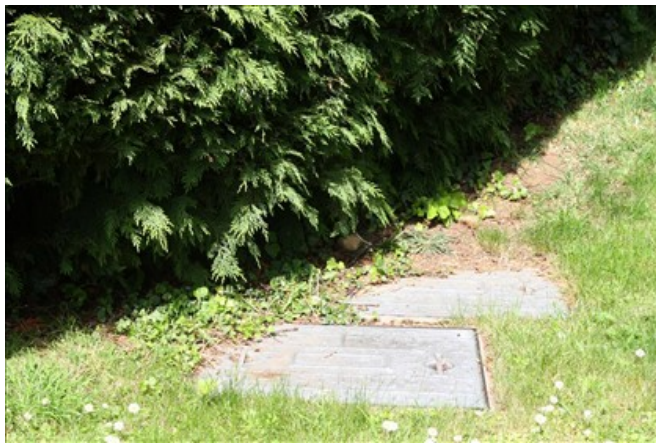
| <p><b>F6.<br/>Drainage</b></p> | <p>it was not possible to lift the access covers as they are partly buried.</p> | <p>NI</p> |

Inspection chambers not opened

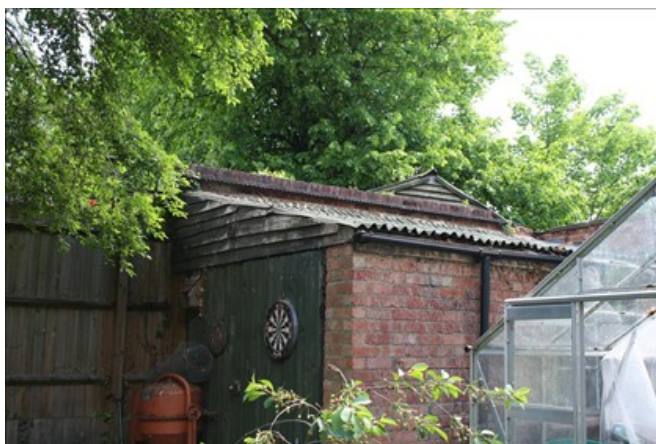
The outbuilding to the rear is of brick construction, with a corrugated roof and is in a poor condition. The outbuilding was locked and only inspected externally but I believe that the roof leaks and should be replaced in the near future to prevent further damage.

Rear outbuilding

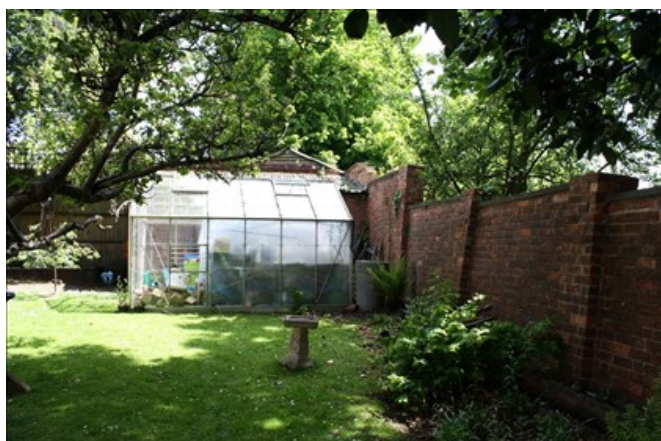
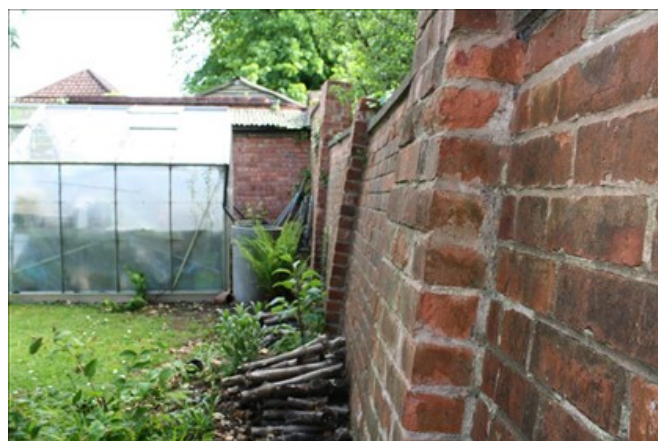
The boundary rear walls are brick built. These are in a poor condition and some works of repair are required. The wall leans away from the property but is supported on the other side by brick piers. These piers should be maintained regularly to ensure that the wall does not fall over.

Rear boundary wall
