# BUILDING SURVEY REPORT

**PROPERTY** Sample Survey  
Anytown  
AA11 1AA

**SURVEY DATE** 2 Jan 2018

**REF** 12345

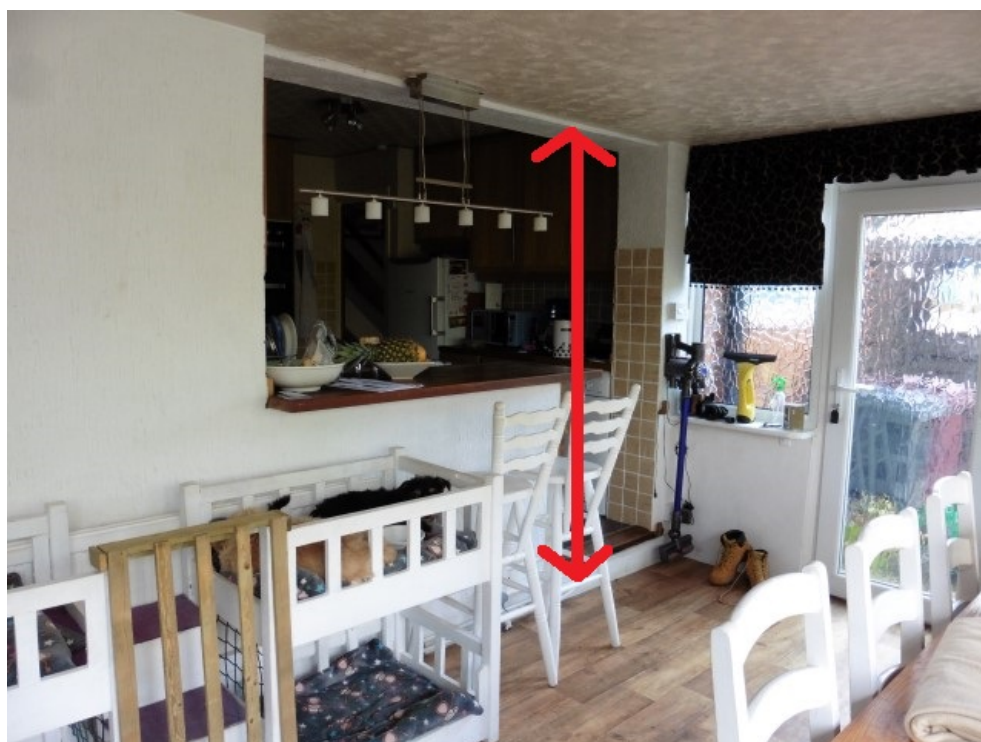
Wall partially removed between the kitchen and sun room

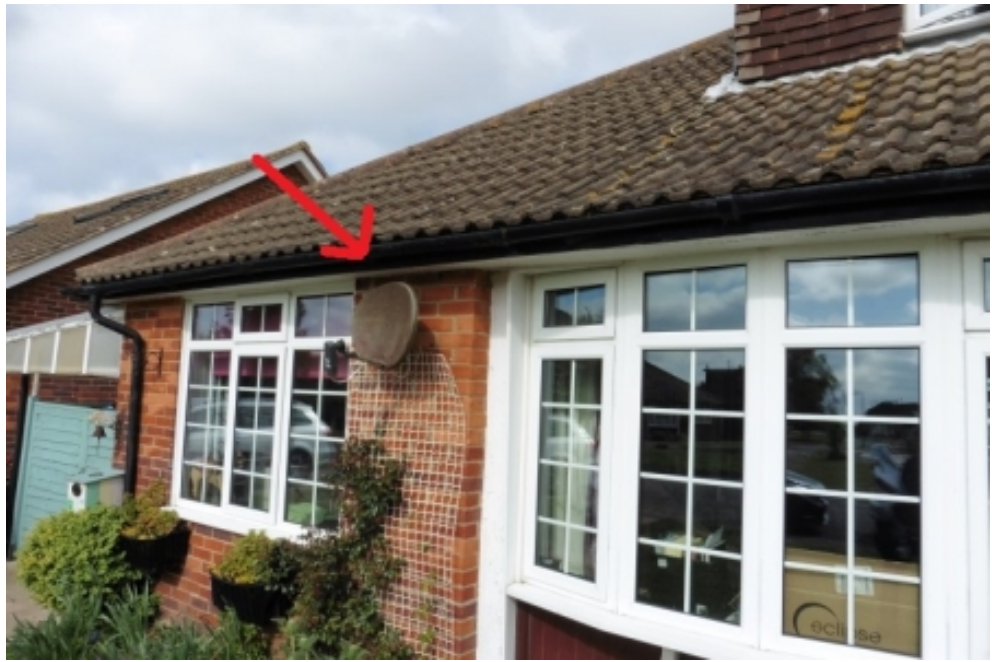
| <b>Condition</b> | No significant defects were noted.<br>No evidence was seen of excessive staining of the walls or adjacent areas, which might indicate that significant leaks have been occurring.<br><br>However, it was noted that the gutter at the front is sagging slightly in the area above the satellite dish, which may mean that it leaks.<br><br>From a purely visual inspection it is impossible to determine whether water from the gutters and downpipes is directed into the mains drains or into soakaways as all of these elements would be under the ground in any case. | | |

Sagging gutter at the front

| <b>Action<br/>Required</b> | The gutter at the front should be repositioned to ensure that it is not sagging or leaking. This is not considered to be work of an urgent or major nature, but should be carried out as soon as possible to prevent further damage to the building.<br><br>Gutters and downpipes should be cleaned and inspected ..... | | |

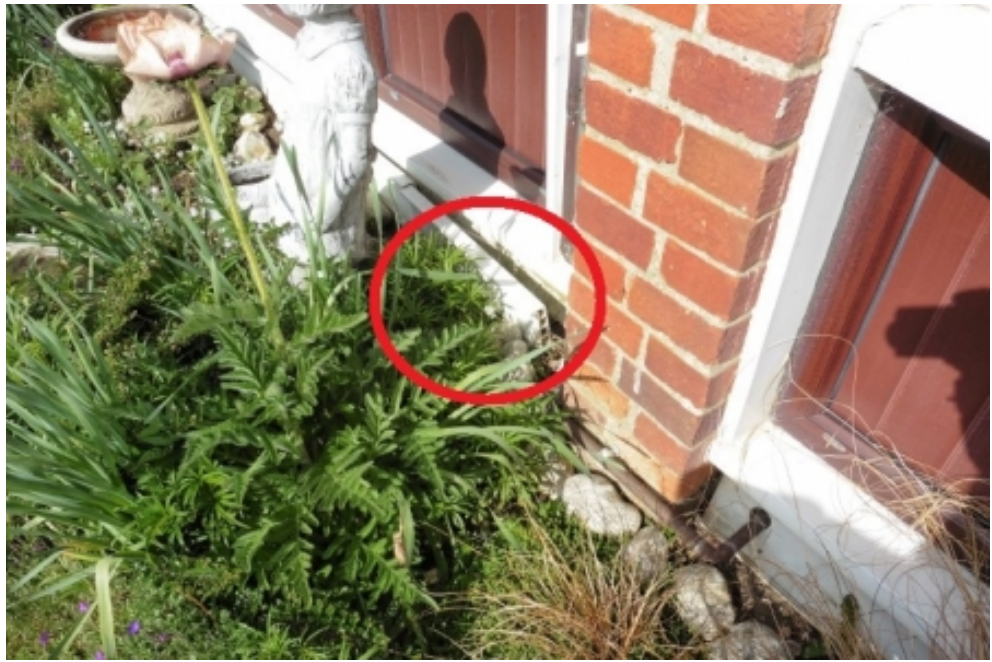
Loose plastic trim at the front

| <b>Action Required</b> | <p>Walls should be examined regularly to inspect for changes in the nature of any cracking or other defects that may become apparent.</p> <p>You should carry out a thorough visual inspection at least once a year, ideally in the Spring to identify and repair any damage that could have been caused by winter weather.</p> <p>The plastic trim at the front should be repositioned.</p> | | |

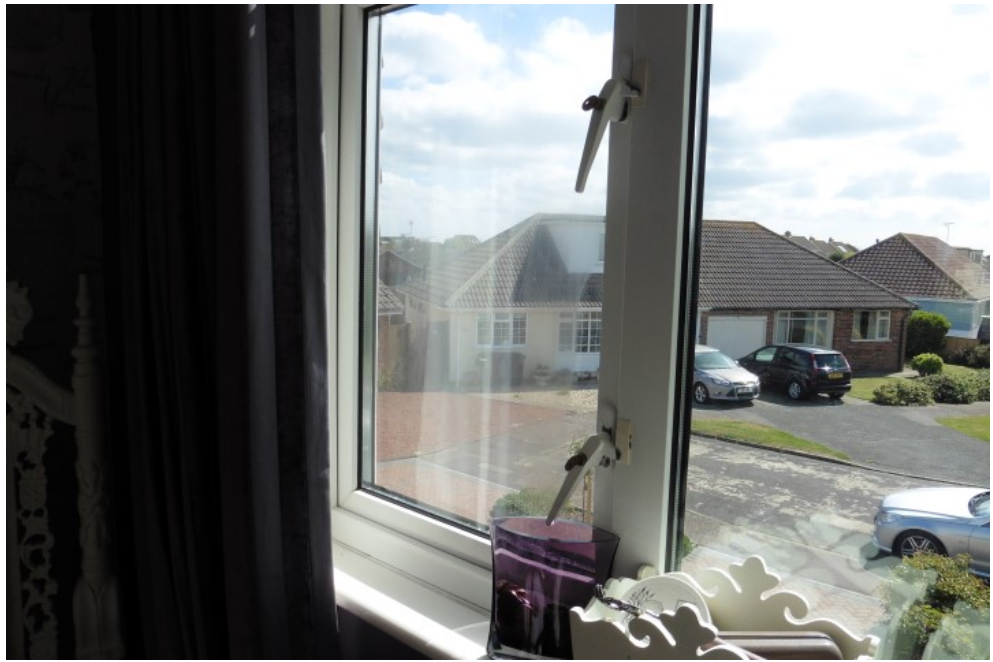
| <b>Condition</b> | <p>No significant defects were noted and most of the windows and doors checked were found to operate normally. However, some were found to be quite difficult to operate, probably due to a lack of lubrication of locks and hinges.<br/>The handle of the bathroom window on the ground floor is stuck in the open position.</p> <p>A failed sealed window unit was noted in bedroom 1, and other weather conditions may highlight the presence of more. This occurs .....</p> | | |

Bedroom 1 casement window panel blown

| <b>Action<br/>Required</b> | <p>Under normal circumstances sealed double glazed units can be expected to last between 15-20 years before the seals begin to .....</p> <p>Failed sealed double glazing units require replacement. It should also be considered that, where some sealed units within a window have failed, others may also fail in due course.</p> <p>Normal maintenance of frames, hinges and locks is required. This includes repair of the bathroom window and the bedroom 1 seal and frame.</p> | | |

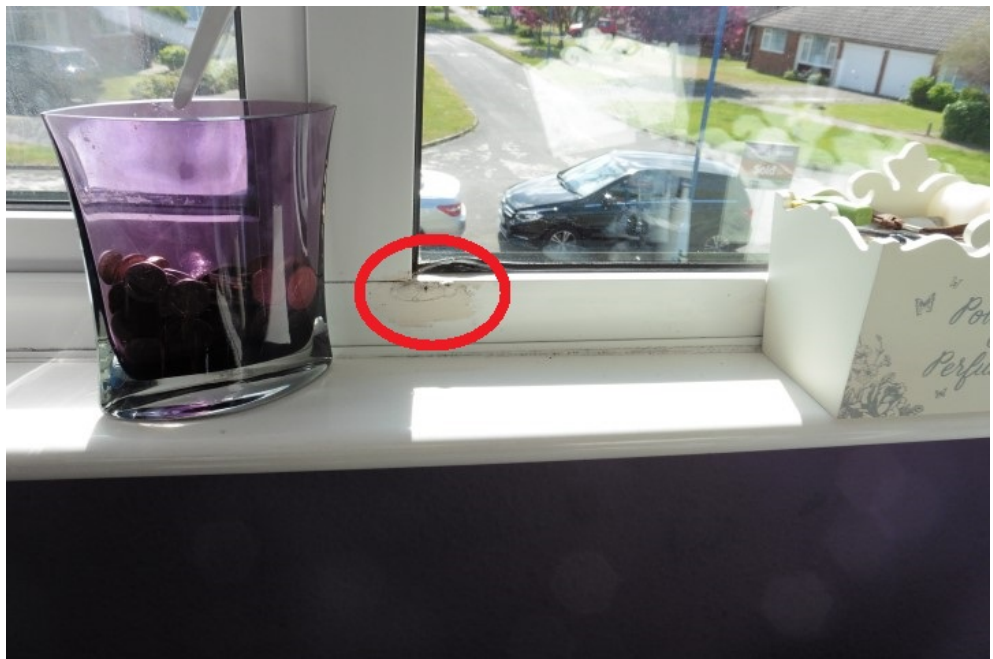
Damage to frame and seal in bedroom 1

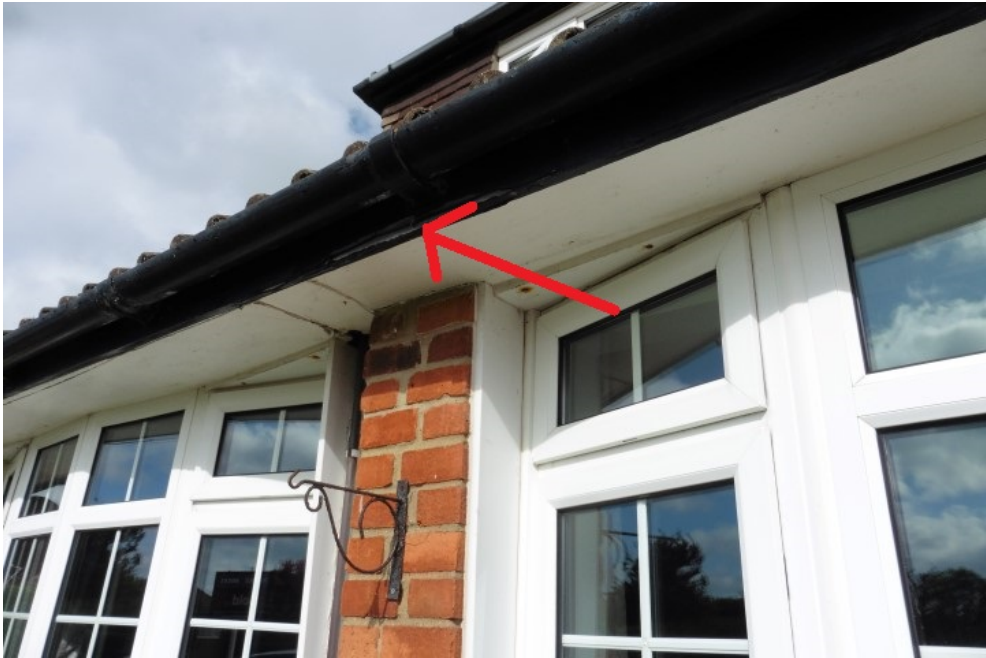
| <b>Condition</b> | <p>Widespread evidence was found of rot in the external joinery, including both the fascias at the front and the soffits at the back.<br/>The timber is failing and what we have spread to other parts of the building.</p> | | |
| | <div data-bbox="416 1122 1406 1778"> </div> <p>Rot in the fascia at the front</p> | | |

| <b>Action Required</b> | <p>Urgent repairs are required to replace rotten timbers around the edges of the roof.<br/>Although some areas of rot were identified, others may be present, and it is possible that the ends of the roof rafters may have been affected.<br/>A thorough investigation should be carried out to identify all rotten timber, which should be cut out and replaced.<br/>This work is considered to be of an urgent nature and should be carried out immediately upon occupation of the property.</p> | | |

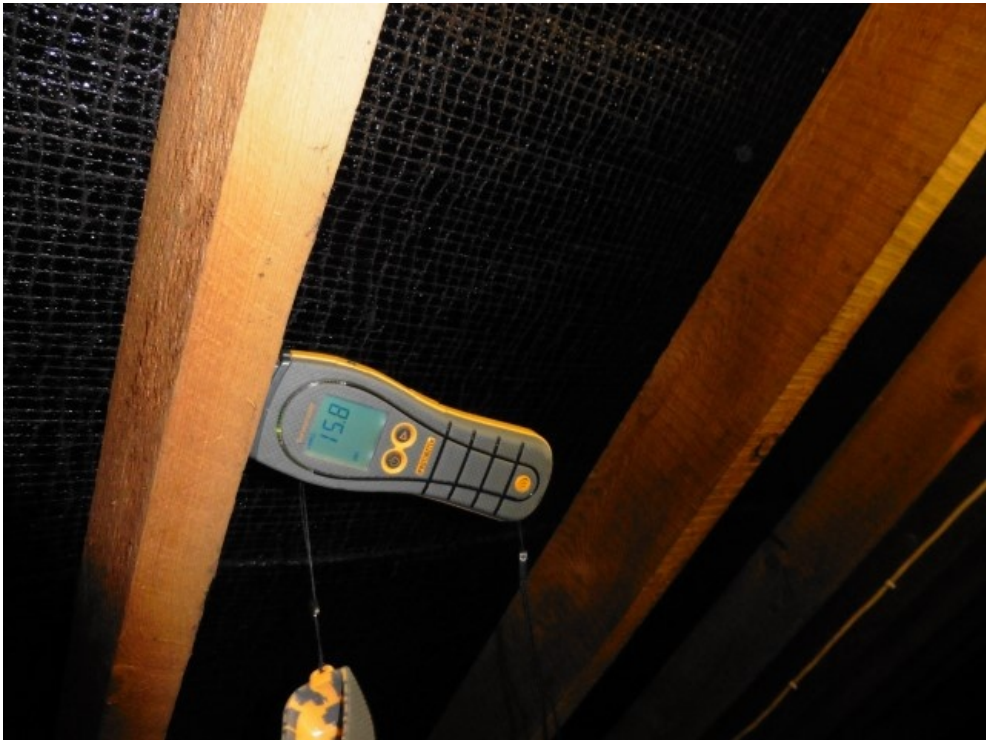
Normal moisture reading in roof timber

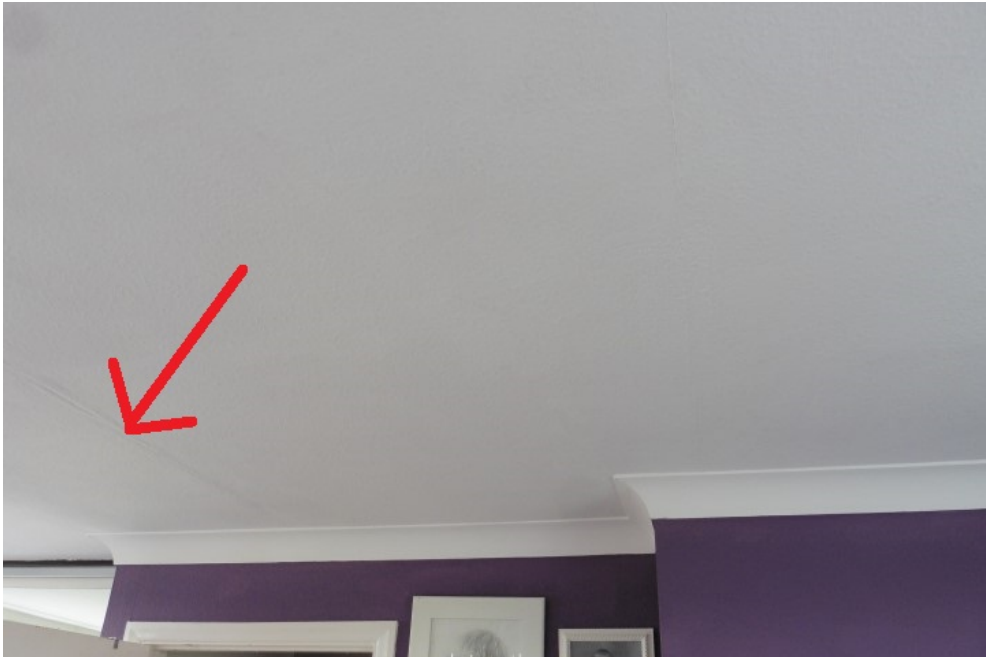
| <b>Condition</b> | No significant defects were noted.<br>Some cracking of the ceiling finishes was noted, for example in bedroom 1. These cracks are primarily along the lines of plasterboard joints and are unlikely to be symptomatic of undue movement of the property. | | |
| | <div data-bbox="416 911 1406 1565" data-label="Image"> </div> <p data-bbox="692 1585 1129 1615">Straight cracks on the bedroom 1 ceiling</p> | | |

| <b>Action<br/>Required</b> | Normal maintenance is required, including filling and redecorating cracks as necessary. | | |

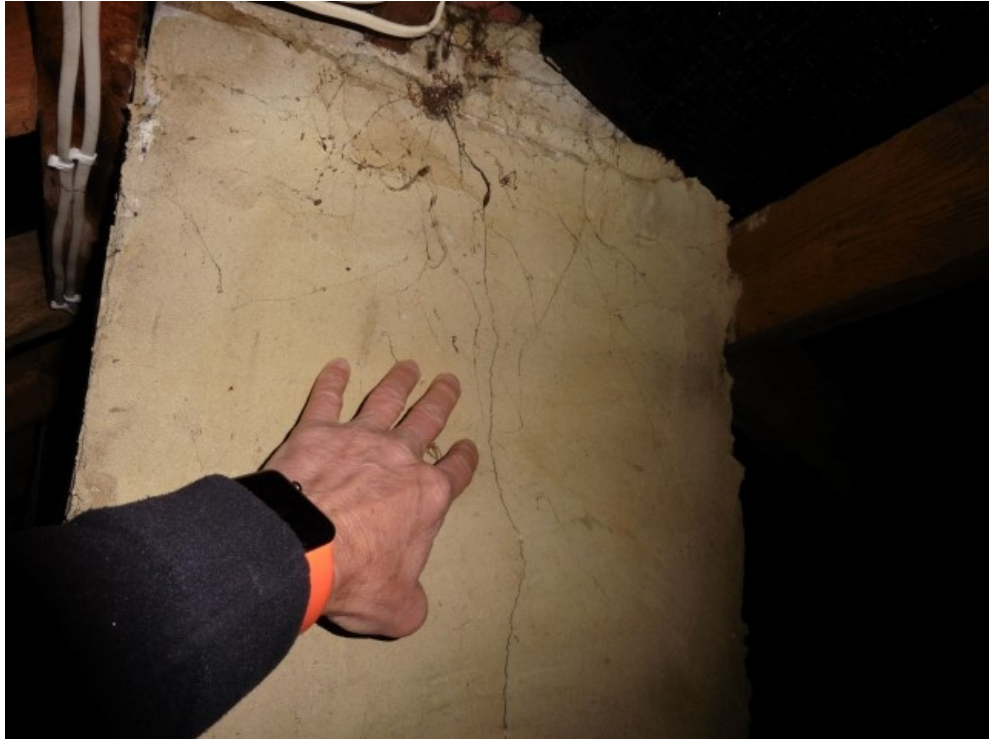
| <b>Condition</b> | <p>Although no specific evidence of any structural defects was identified, it is possible that some changes have been made to the right side chimney breast which have the potential to lead to structural failure.</p> <p>Within the kitchen there is no lower part to the chimney breast. Although this type of arrangement is not unusual and was usually accompanied by a flue pipe leading to a boiler or stove beneath, without knowing the history of the building it is impossible to confirm that this is how it was constructed and that is not been altered. In the roof space above there is some light cracking of the chimney breast, and although it is unlikely that this is due to any structural failure, from a single visual inspection it is impossible to be completely sure that this is the case.</p> <p>The left side chimney breast, serving the fireplace in the living room is, as far as can be determined, in a stable condition.</p> | | |

Light cracking of the right side chimney breast in the roof space

| <b>Action Required</b> | <p>Enquiries should be made to determine whether any alterations have been carried out to the chimney breast in the past.</p> <p>A structural engineer.....</p> <p>.....</p> | | |

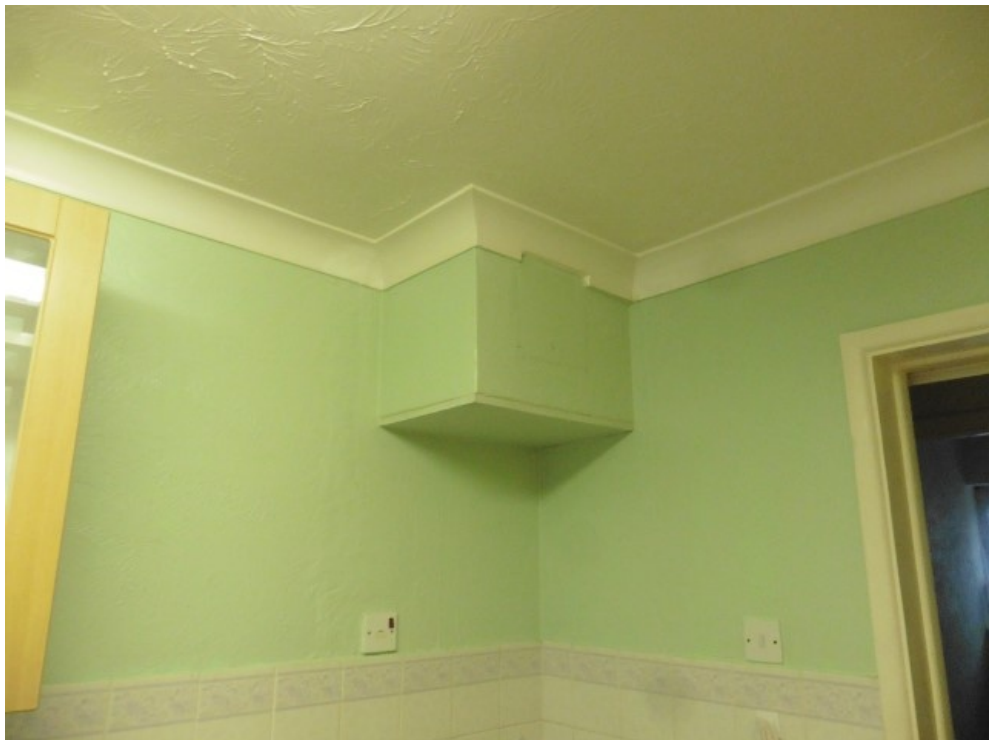
Right side chimney breast in the kitchen has been truncated

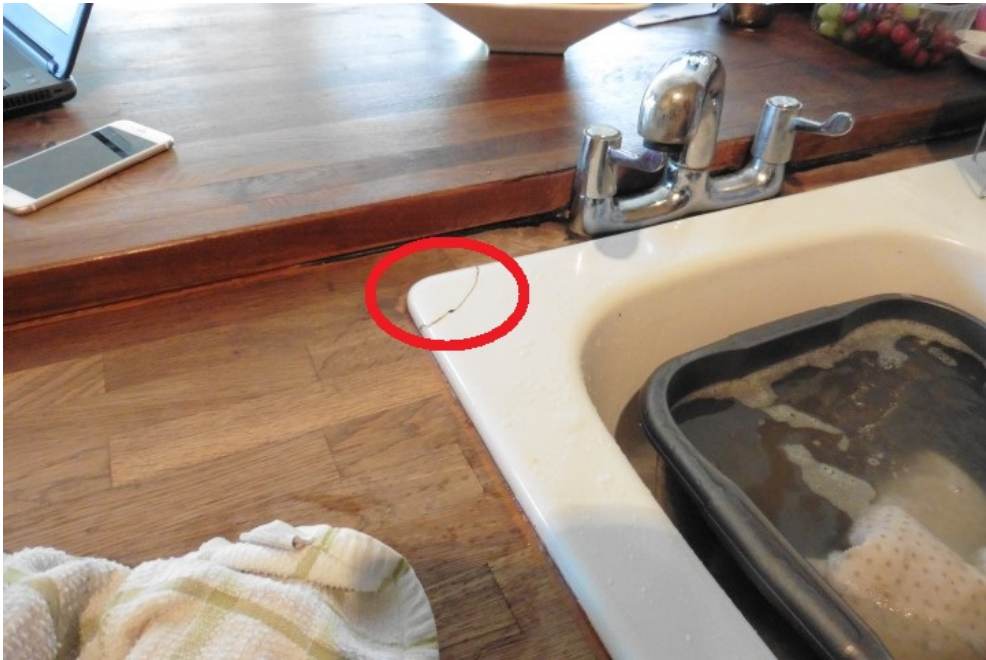
| <b>Condition</b> | <p>The kitchen fittings are of a modern style and in a serviceable condition. It is understood that they were installed by the current owners.</p> <p>The flow of water at the sink was checked and was within a normal range and considered to be suitable for the intended use.</p> <p>Hot water was obtained from the kitchen hot tap.</p> <p>Fitted cupboards and wardrobes are of a basic style and, generally in a serviceable condition.</p> <p>The cooker hood was found to be noisy in operation.</p> <p>The edge of the kitchen sink is cracked and will require repair.</p> | | |
| | <p>Cracked edge to the kitchen sink</p> | | |

| <b>Action Required</b> | <p>Maintain, repair or replace units as necessary.</p> <p>The fan within the cooker hood should be replaced.</p> <p>The kitchen sink will require replacement as it is cracked.</p> | | |

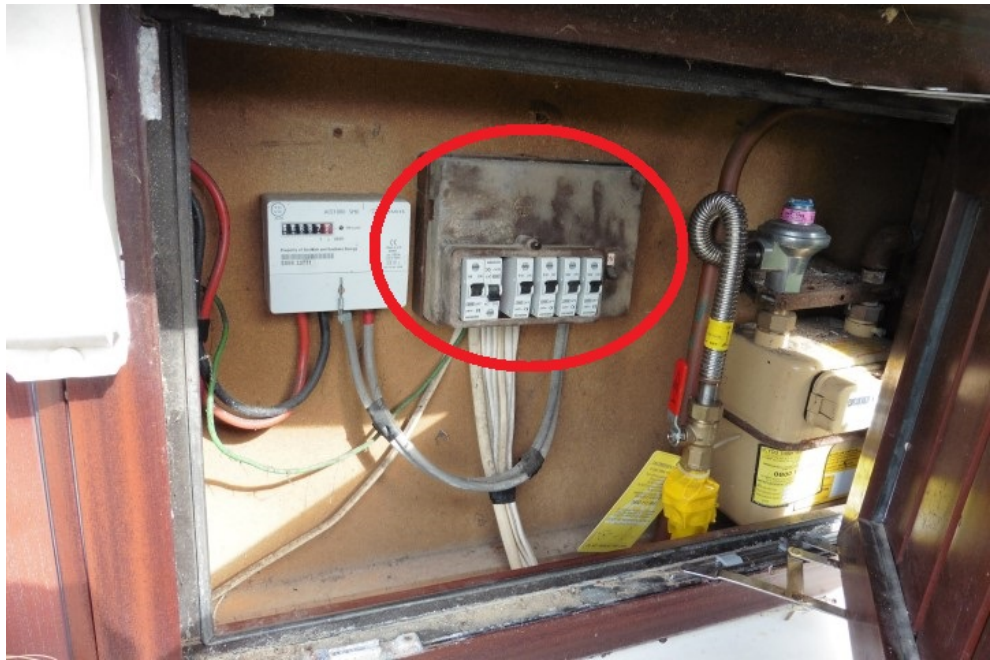
Fuse board

| <b>Condition</b> | <p>The fuse board is of an older type without the more modern RCD protection devices installed, suggesting that it has not been upgraded recently. It must be assumed, therefore, that much of the installation dates from the 1970s or before and is, therefore, out of date.<br/>Although it was impossible to see most of the sockets in the rooms around the house, extension leads suggests that there are insufficient outlets for modern purposes.<br/>Power supplies to the sheds within the garden are, clearly, of an amateur nature and unlikely to meet reasonable safety standards. These supplies were noted to be of non-armoured cable.</p> | | |

| <b>Action<br/>Required</b> | <p>The NICEIC recommends that electrical installations are subjected to an Electrical Installation Condition Report (EICR) by a competent person at least every .....</p> | | |

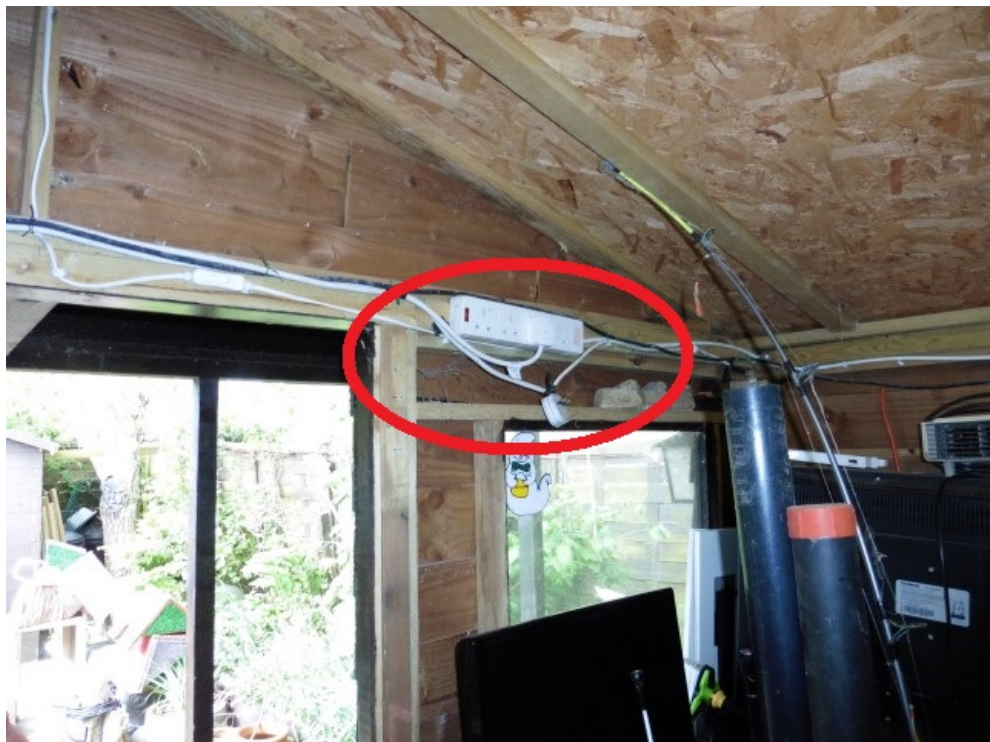
Poorly managed wiring in shed 4

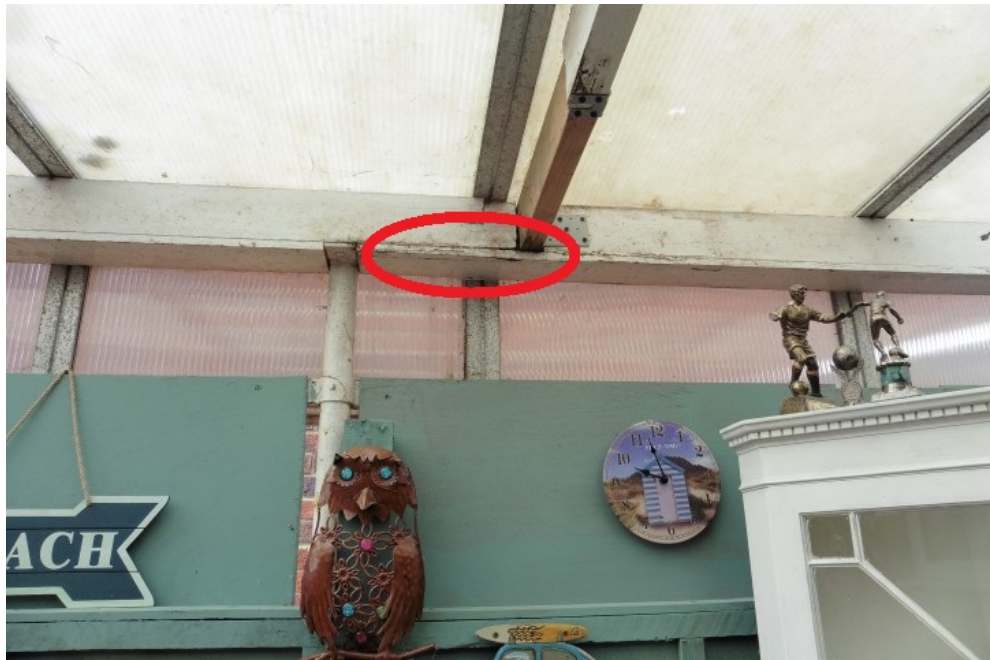
Possibly rotten timbers in the lean-to

| <b>Action<br/>Required</b> | <p>Normal maintenance, including regular retreatment of the walls, is required.</p> <p>Foliage and debris should be removed from the outside walls.</p> <p>Compared to traditional coverings such as tiles and slates, most felt roofs have .....</p> <p>.....</p> | | |
