# Home Condition Survey

8, Rowan Way  
NORTHAMPTON  
NN5 0DT

Report Reference No: 5359009  
Date: 26-May-2015  
Surveyor: Mrs Carolyn Clay

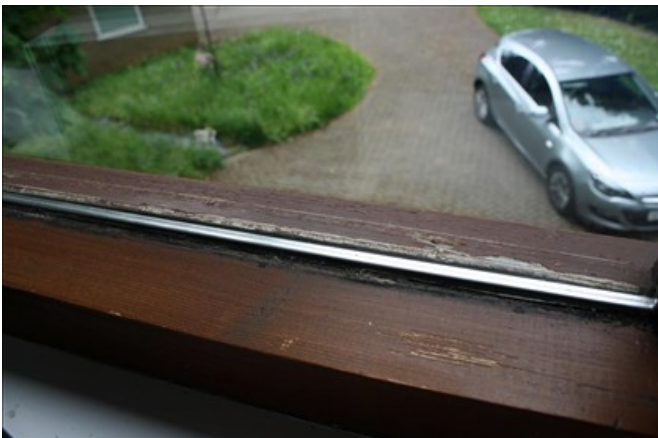
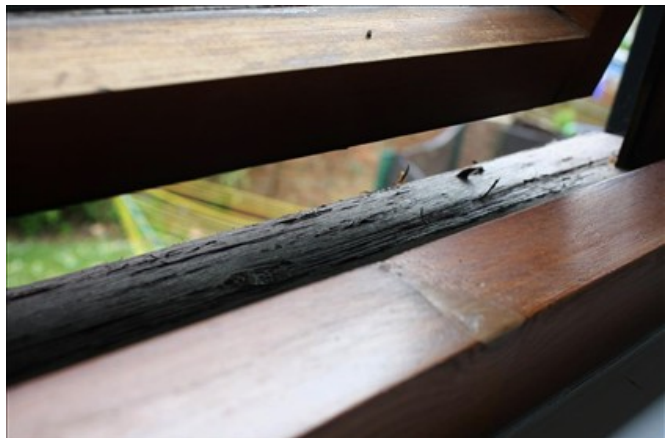
| <p><b>D9.</b><br/><b>Outside decoration</b></p> | <p>Decorated areas may include such items as windows, doors, walls, timbers at roof edges, porches.</p> <p>The external timbers are stained.</p> <p>The staining to the first floor windows, window and door cills, and Utility Room fascia is flaking and requires renewing.</p> | <p>2</p> |

Internal 1st floor window

External & Internal 1st floor window

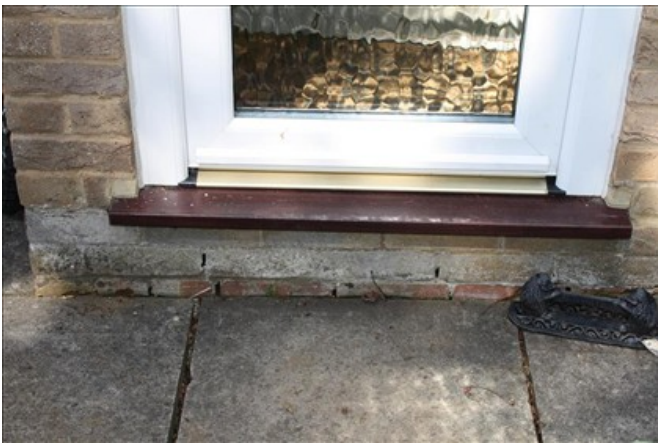
Rear door threshold

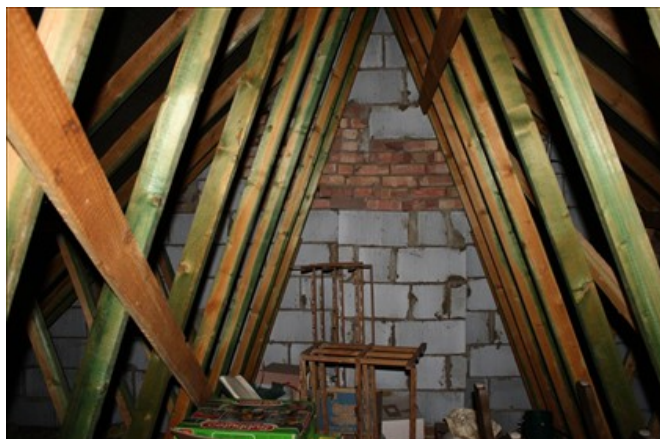
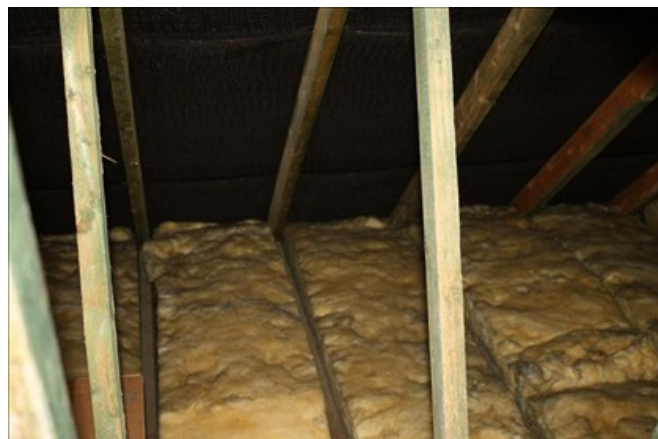
| | Description and Justification for Rating and any comments | Condition Rating |
|---|---|---|
| <b>E1.<br/>Roof structure</b> | <p>The roof structure uses standard pre-formed timbers trusses held together with nail plates. Lateral movement is restrained by straps tying the roof to the gable walls and bracing timbers with the roof in accordance with good practice. The sarking felt under the roof tiles can be viewed. See Section D1</p> <p>The insulation within the roof is in fibreglass quilting which is laid between the joists to a depth of approximately 200mm.</p> <p>The presence of the boarding to the middle section restricts the inspection of insulation and joists in this area.</p> <p>No repair is presently required. Normal maintenance must be undertaken.</p> | <b>1</b> |

Loft structure

Loft insulation

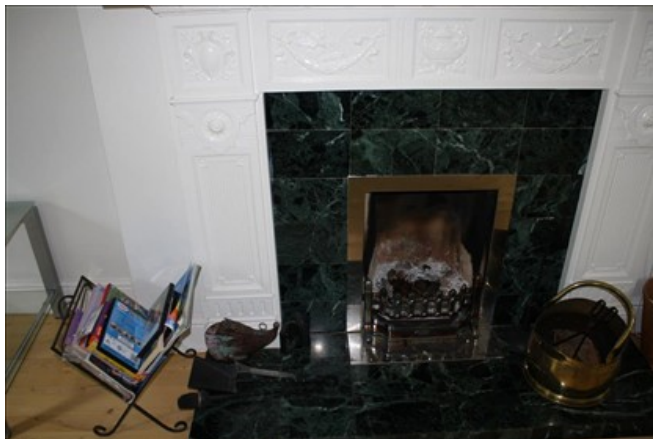
| <b>E5.</b><br><b>Fireplaces</b><br><b>&amp;</b><br><b>chimney</b><br><b>breasts</b> | <p>The chimney breast is of masonry construction and a fireplace remains in the Lounge. There is evidence that this is currently in use as a log fire.</p> <p>I have not carried out a smoke test of the chimney as this is beyond the scope of this inspection. Before any open fire is lit you should seek the advice of a HETAS approved chimney sweep. (for more information see the HETAS website at <a href="http://www.hetas.co.uk/find-chimney-sweep/">www.hetas.co.uk/find-chimney-sweep/</a>).</p> | <p>1</p> |

Fireplace

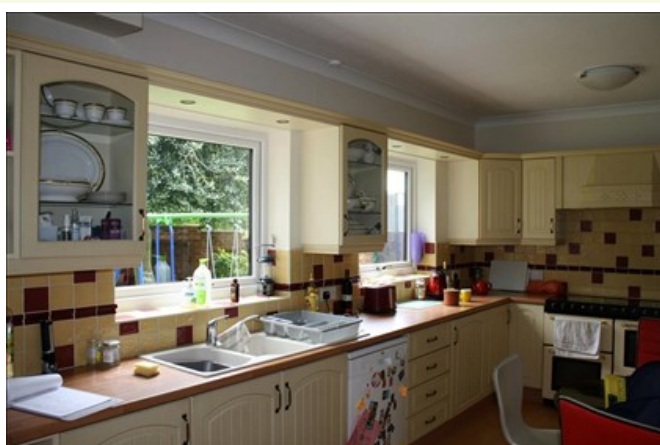
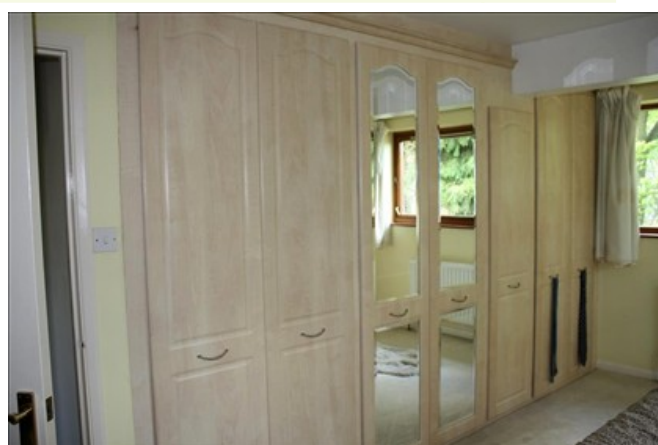
No repair is presently required. Normal maintenance must be undertaken.

Kitchen cupboards

Master Bedroom cupboards

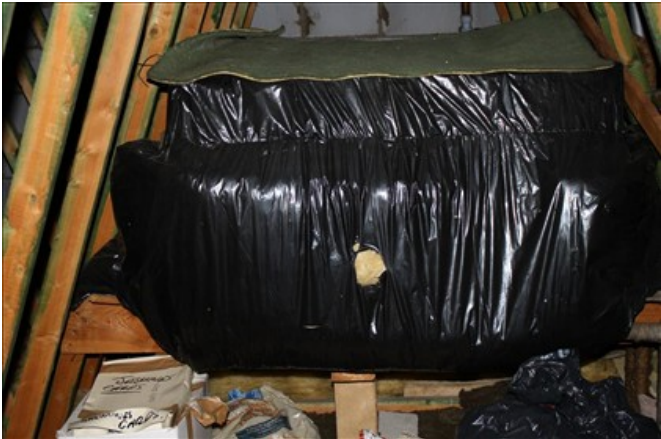
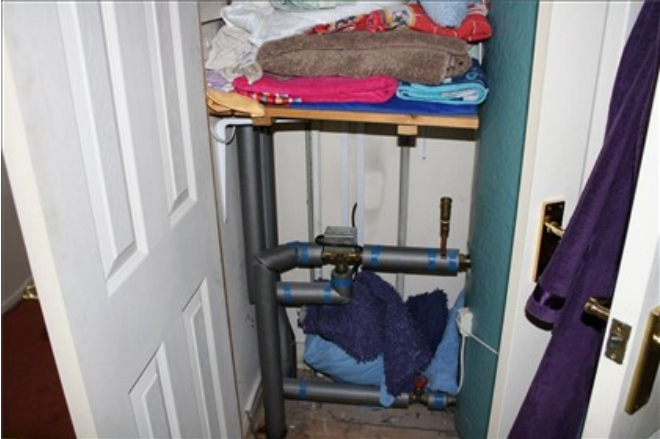
| <p><b>F4.<br/>Water</b></p> | <p>The property is connected to the mains water supply. The internal stopcock is beneath the sink in the utility room. The incoming mains supply pipe is in copper.</p> <p>Within the loft, there are two tanks. One is for cold water storage and the other is the expansion tank for the central heating and hot water boiler. They are formed in PVC and are provided with lids, insulation and overflow pipes.</p> <p>Hot water is produced by the central heating boiler and stored in a factory insulated copper cylinder in the master bedroom. There is an emersion heater and a fitted thermostat.</p> <p>No leaks were discovered from the tanks or the surrounding pipework.</p> <p>No repair is presently required. Normal maintenance must be undertaken.</p> | <p>1</p> |
| <div> </div> <div> <p>Cold water tank in loft space</p> <p>Hot water cylinder and insulated pipes</p> </div> | | |
