# BUILDING SURVEY REPORT

**PROPERTY** Sample Survey  
Anytown  
AA11 1AA

**SURVEY DATE** 2 Jan 2018

**REF** 12345

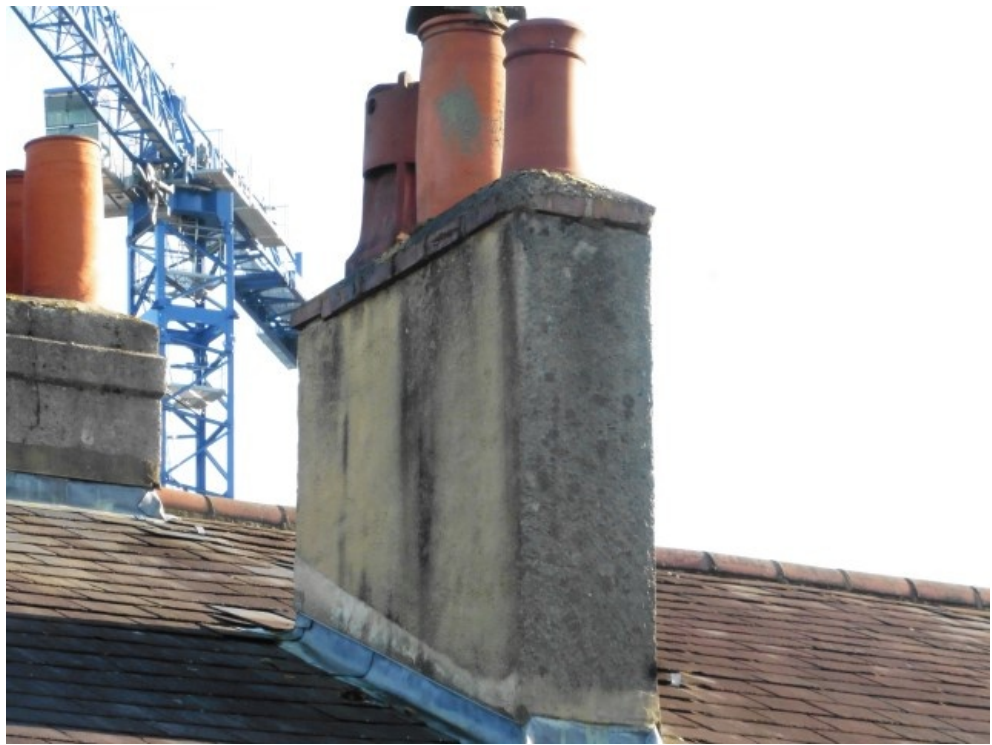
| <b>Condition</b> | <p>No significant defects were noted and the chimney stacks were found to be structurally stable. No evidence was seen of any unusual cracking or other failure, or of unusual wear of the bricks or mortar pointing between the bricks.</p> <p>The flashings at the base of the stacks are, as far as can be seen, in a serviceable condition.</p> | | |

Rear stack viewed from the rear

| <b>Action<br/>Required</b> | <p>The chimney stacks should be regularly monitored for any indications of damage, instability or other defects. You should carry out a thorough visual inspection at least once a year, ideally in the Spring, and ideally at roof level, to identify and repair any damage that could have been caused by winter weather.</p> <p>Missing, loose or defective mortar should be repointed as necessary.</p> <p>It is advisable to fit cowls on the top of the pots of any open flues.</p> | | |

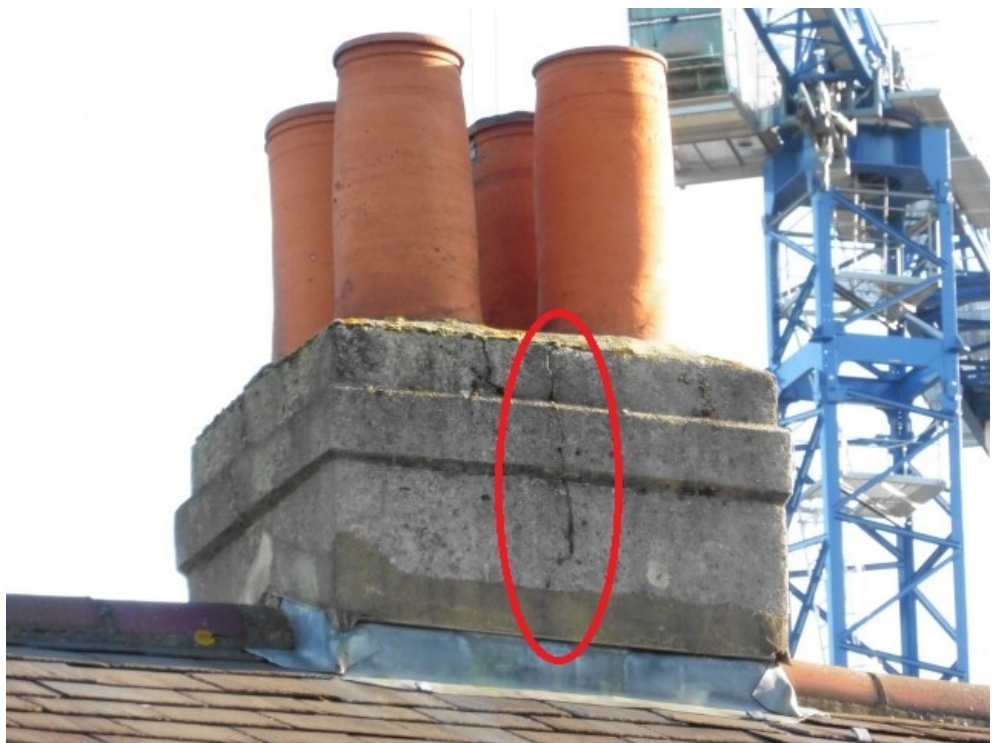
Central stack viewed from the front

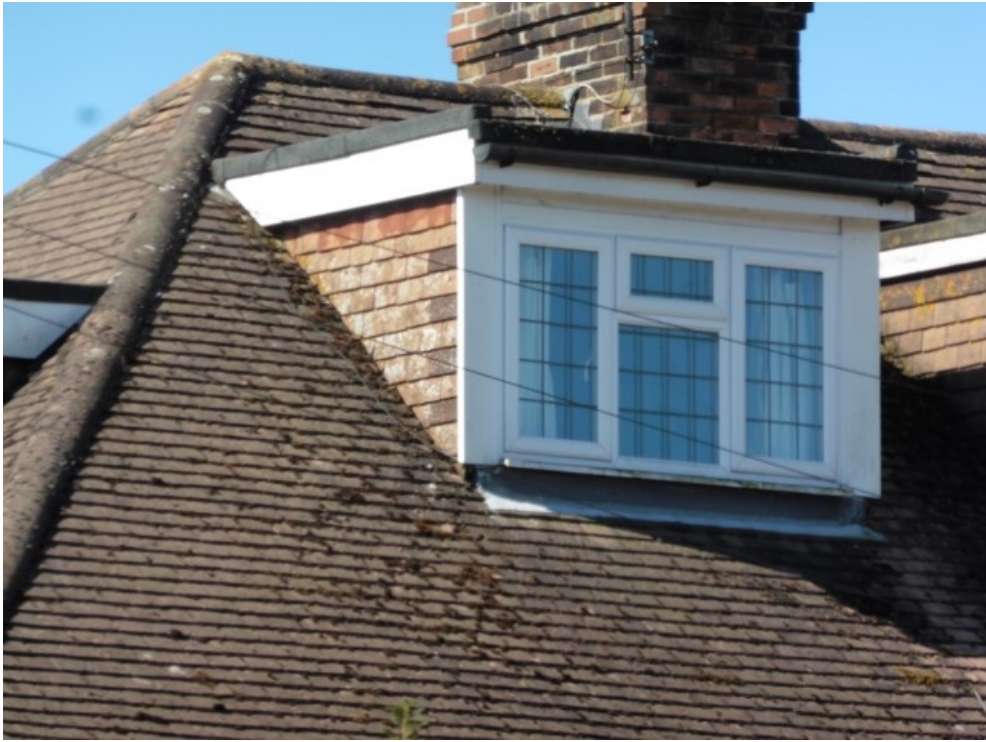
| <b>Condition</b> | <p>No significant defects were noted and the main roof was found to be structurally stable. No evidence was seen of unusual sagging or other movement which might indicate that the structure is failing.</p> <p>No evidence was seen of any unusual amounts of moss growth, or of slipped, chipped or cracked tiles.</p> | | |
| | <p>Front roof and dormer</p> | | |

| <b>Action Required</b> | <p>Carry out normal maintenance including removal of moss build-up.</p> <p>Any slipped, missing or broken tiles on the roof pitches should be repaired and replaced.</p> <p>You should carry out a thorough visual inspection at least once a year, ideally in the Spring to identify and repair any damage that could have been caused by winter weather.</p> | | |

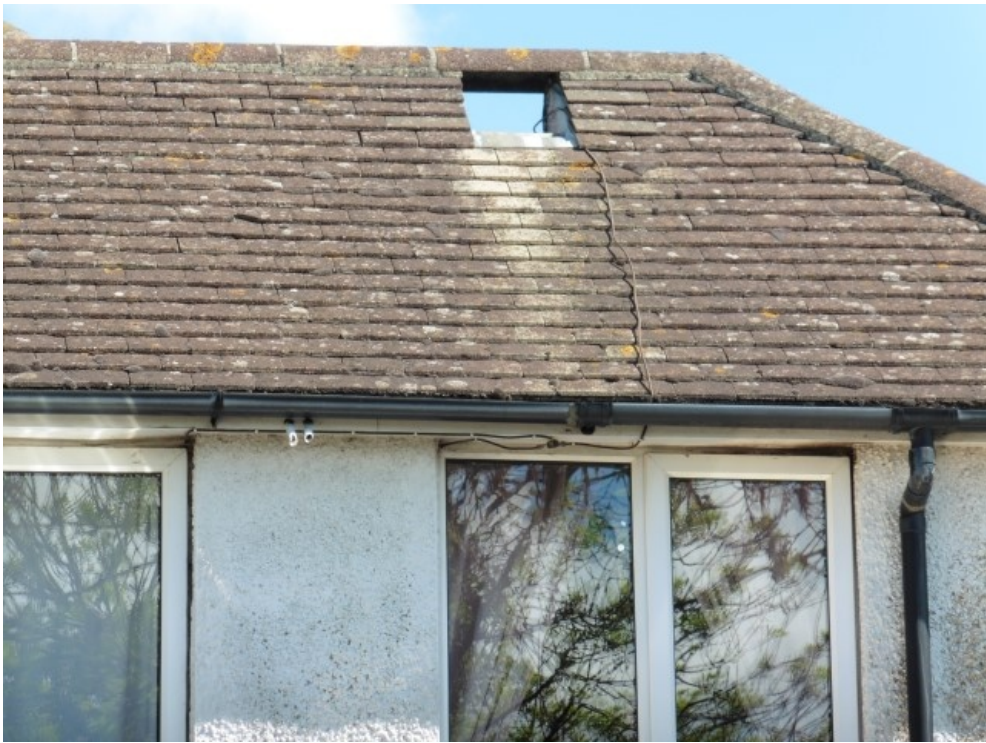
Rear roof pitch

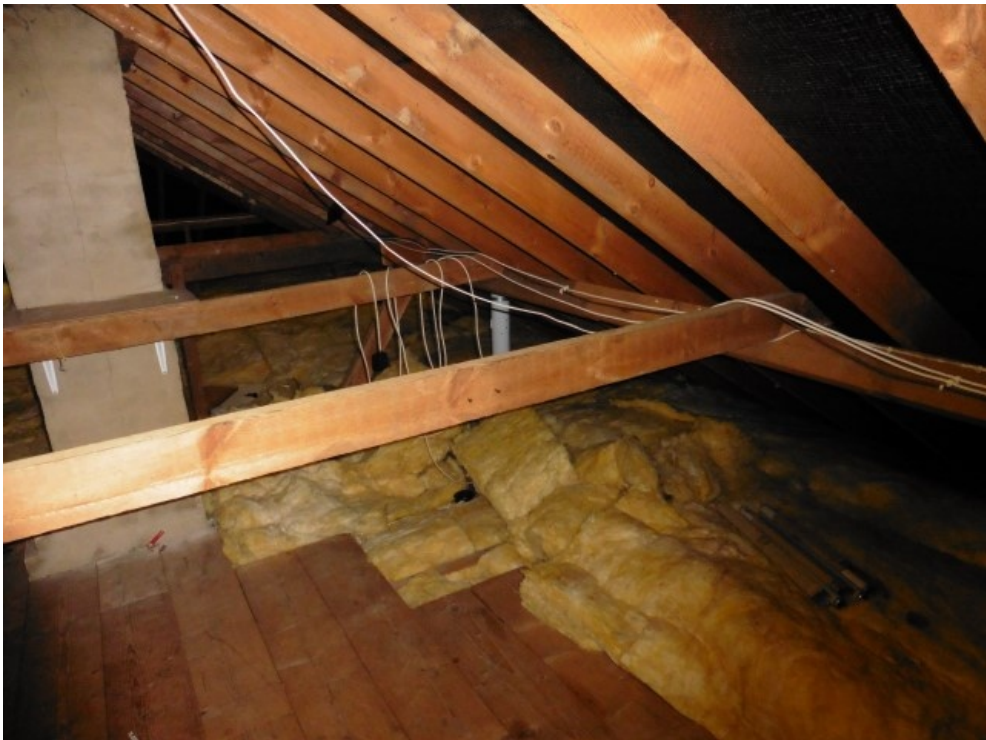
| <b>Condition</b> | <p>No significant defects were noted during my inspection and the roof was found to be structurally sound.<br/>No evidence was seen of any unusual movement or stress of the supporting timbers within the roof, and there have been no obvious significant alterations to the structure which might have resulted in it becoming substantially weakened.</p> <p>The roof space is laid with 200-300mm of .....</p> <p>High moisture levels within roof spaces are responsible for the promotion of the development of timber defects such as rot and infestations by wood boring insects (commonly known as woodworm). Wood moisture content readings taken were found to be well within normal limits and below the levels normally required for this type of defect.</p> | | |

Looking towards the right

| <b>Action<br/>Required</b> | <p>Although no evidence of active infestations of wood boring insects was identified, it is important to remain vigilant and be aware that such infestations can become active after long periods of inactivity.</p> | | |

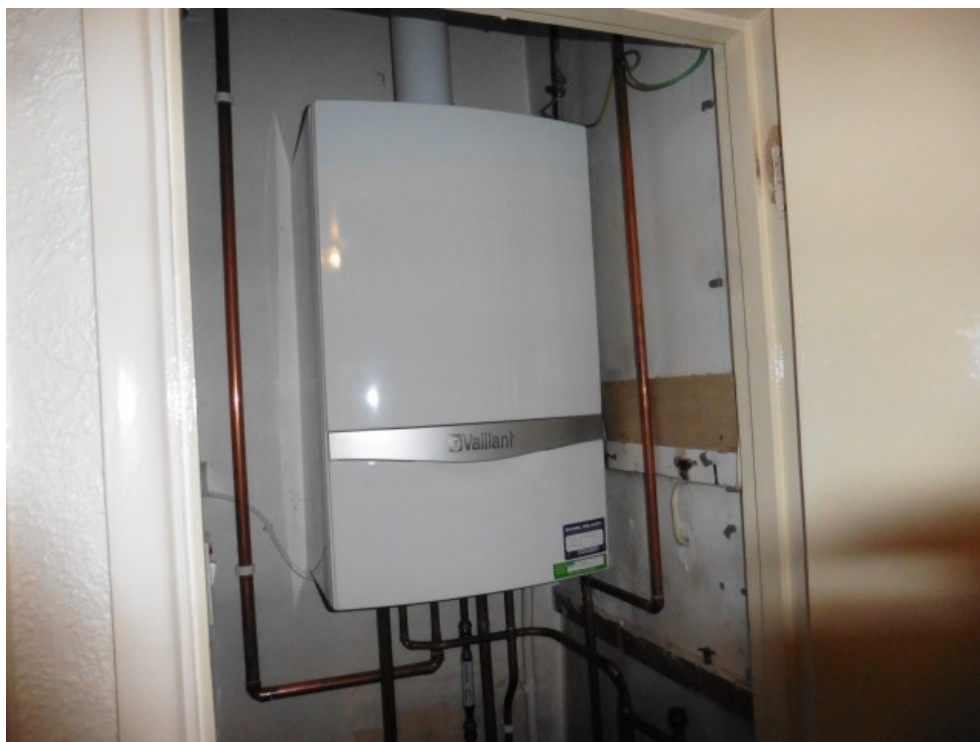
Boiler

| | <b>6.4 Heating and Cooling</b> | <b>Condition<br/>rating</b> | <b>HS</b> |
|---|---|---|---|
| <b>Condition</b> | <p>Documentary evidence was seen to indicate that the boiler was serviced in December 2015 and that checks confirm that the contractor is Gas Safe registered.<br/>The seller indicated that the boiler had been installed in 2009. This means that it is approximately eight years old and, therefore, around half way through its normal expected service life, subject to regular maintenance.</p> <p>At the time of the survey the heating was checked and the boiler .....</p> | | |

| | <b>6.4 Heating and Cooling</b> | <b>Condition<br/>rating</b> | <b>HS</b> |
|---|---|---|---|
| <b>Action<br/>Required</b> | <p>Gas Safe recommends that all gas appliances and boilers are inspected and serviced according to manufacturer's guidance, but at least once a year. A gas installation can look to be in a safe condition, but serious defects may be hidden, some of which can kill. It is therefore considered to be essential that you commission an inspection of the gas/heating installation prior to purchase of the property, unless you are provided with verifiable evidence that such an inspection has recently been carried out by a competent person.</p> | | |

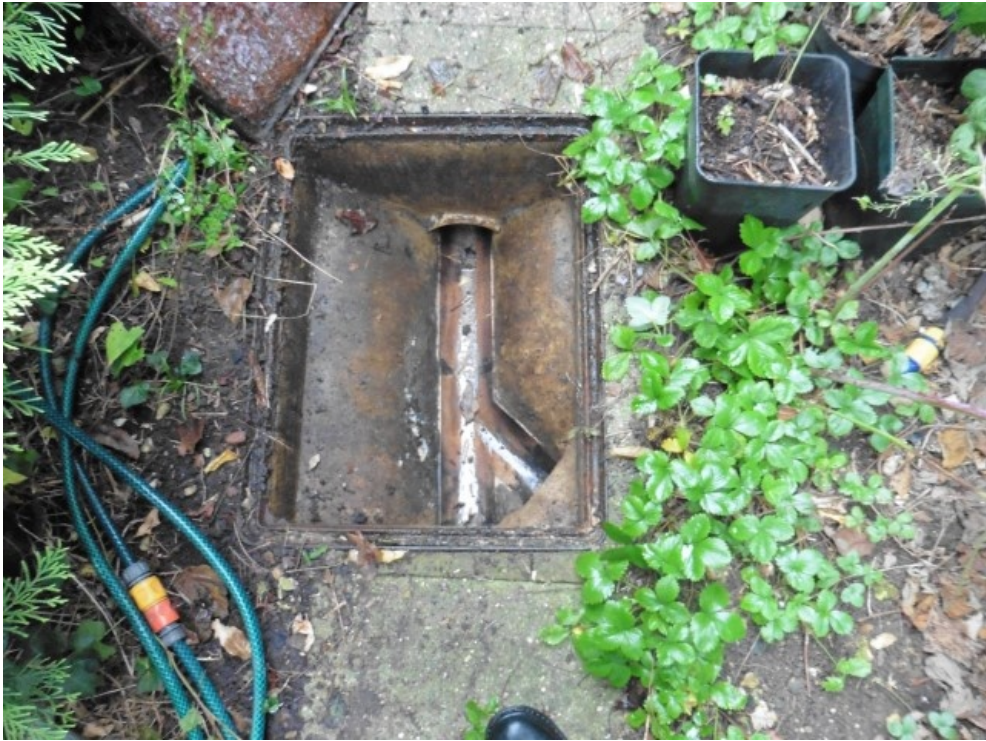
| | <b>6.5 Drainage</b> | <b>Condition<br/>rating</b> | <b>1</b> |
|---|---|---|---|
| <b>Condition</b> | <p>From the inspection carried out it is apparent that waste water is firstly directed to the rear the property whereupon it is directed under the right side path, through the chamber at the front, and from there into the main sewer road.</p> <p>Toilet flush and tap water was seen to run through the drains without any apparent blockages, and the rate of flow suggests that there is sufficient fall on the drains to reduce the risks of blockages.</p> | | |
| | <p>Inspection chamber to the rear</p> | | |

| | <b>6.5 Drainage</b> | <b>Condition<br/>rating</b> | <b>1</b> |
|---|---|---|---|
| <b>Action<br/>Required</b> | <p>Drains should be regularly inspected to ensure they remain free from blockages, tree root damage or other obstructions.</p> | | |

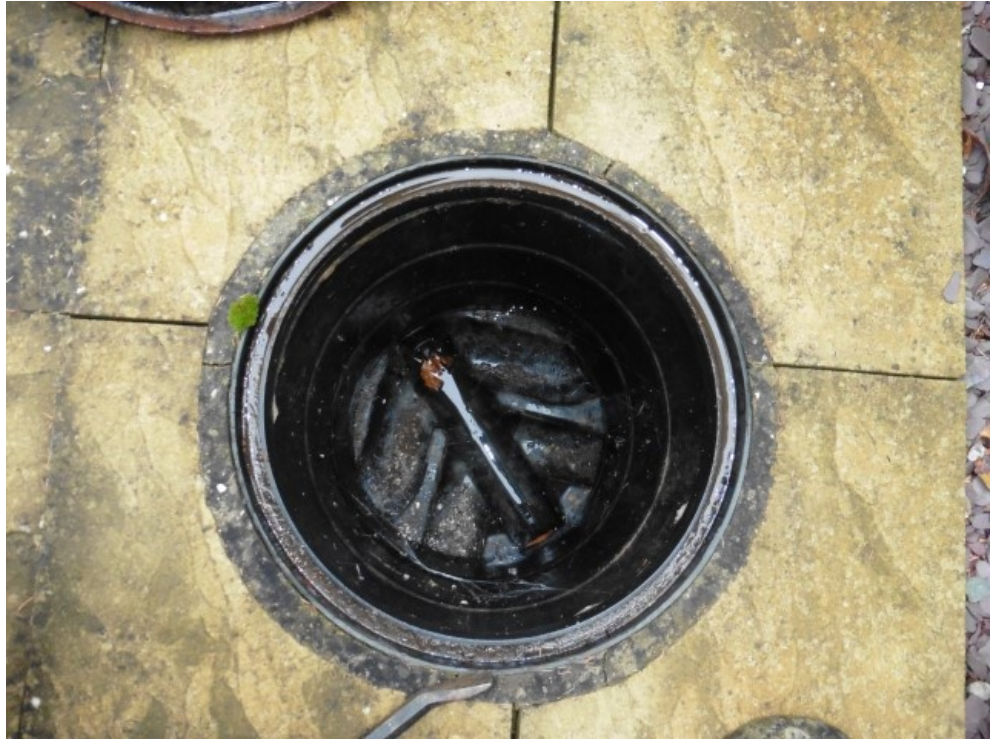
Inspection chamber to the front

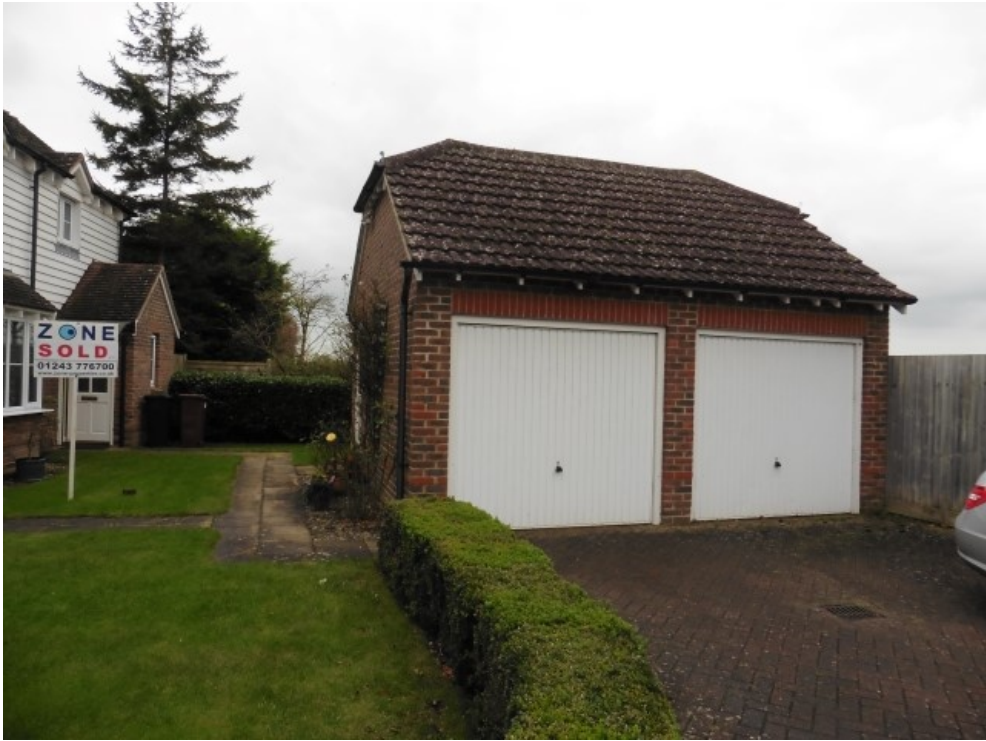
| | <b>7.1 Garaging</b> | <b>Condition rating</b> | <b>1</b> |
|---|---|---|---|
| <b>Condition</b> | <p>The garage was found to be in a stable condition with no evidence of any cracking of the walls of floor which might indicate that it is subject to unusual structural movement such as subsidence or settlement.</p> <p>The roof covering is in a good condition without any undue numbers of slipped or missing tiles.</p> <p>All of the doors were found to operate normally.</p> | | |

| | <b>7.1 Garaging</b> | <b>Condition rating</b> | <b>1</b> |
|---|---|---|---|
| <b>Action Required</b> | <p>Normal maintenance, including regular retreatment of external joinery, is required.</p> <p>Foliage and debris should be removed from the outside walls.</p> | | |

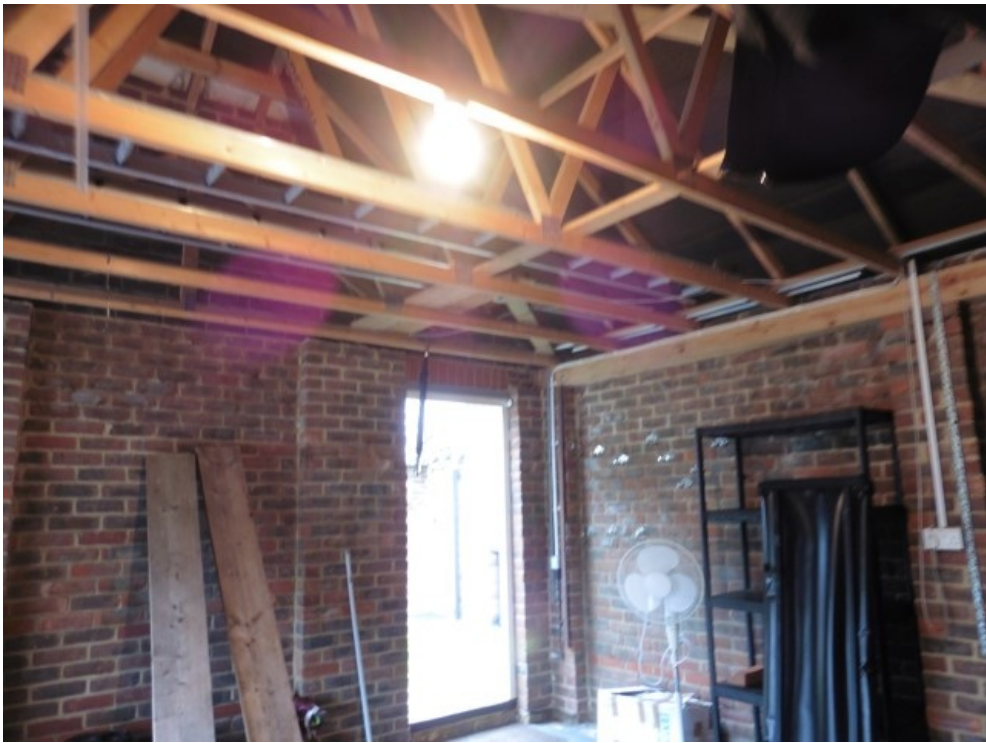
Garage internal review
